# CONCRETE ENGINEERING

Volume 11 Number 2 Summer 2007

# Crystalline waterproofing at hydro-electric power plant

**Work to repair 2km of the main concrete tunnel at a hydropower plant in Italy centred on crystalline waterproofing. The system provides a permanent seal against water ingress and chemical attack and becomes an integral part of the concrete.**

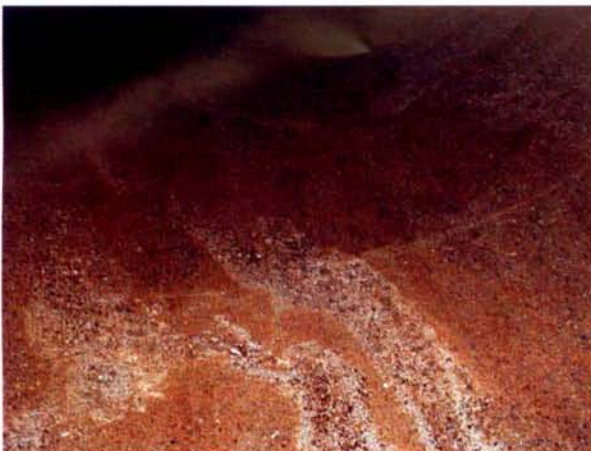
*Figure 1: Tunnel surface after the cleaning operation and before the treatment.*

The repair and waterproofing works became necessary after cracks and water leakage had been discovered in the tunnel. Concrete is a porous material, as evaporating excess water in the hardening stage leaves behind a web of pores, capillaries and micro-cracks through which water can later enter the structure. Cracking can occur at all stages of its lifetime and have a number of causes including design, material and construction defects, damage to the structure due to overload, chemical spill, and fire but also – and in many cases – from deterioration of the structure due to freeze/thaw cycles, metal corrosion, chemical attacks and erosion. The latter

On the project site in Andonno, high hydrostatic pressure had pushed water into the pores and capillaries of the concrete, resulting in the observed leakage. Finally, the solution to repairing the tunnel was found in a crystalline waterproofing system.

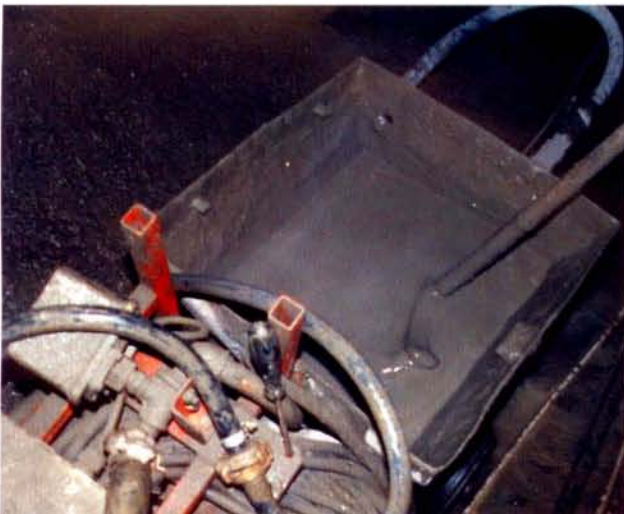
*Figure 2: Mixed powder of crystalline product ready to apply in the spray machine tank.*

Crystalline waterproofing products can be applied to new and existing concrete structures either by brush/spray application (onto existing concrete), dry-shake (to freshly laid horizontal concrete slabs) or as an admixture at the time of batching (to new concrete). Therefore, the concrete surface needs to be clean, damp and to have an 'open-capillary system'.

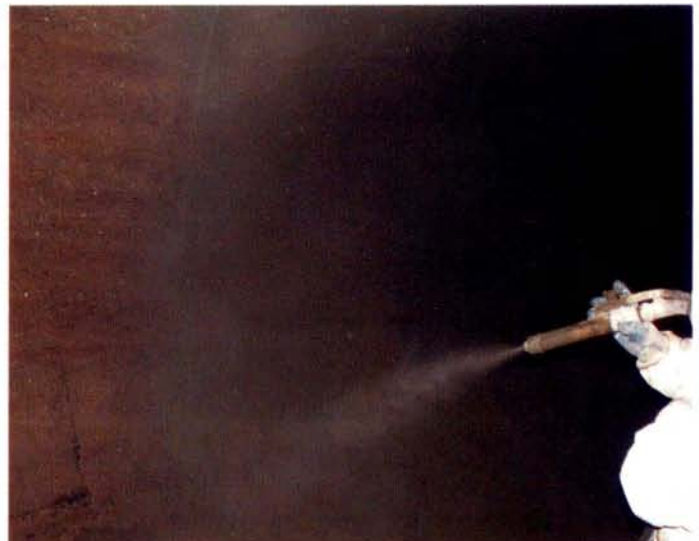
*Figure 3: Spray-application of the slurry.*

In order to waterproof the main tunnel of the Andonno hydro-electric power plant, all active leakage was stopped using resins before the crystalline waterproofing material was applied. All cracks larger than 0.4mm were cut out and chiselled back to a size of 30 x 30mm and were repaired with a crystalline-based mortar. Subsequently, the entire levelled concrete surface of the tunnel section to be repaired (24,000m<sup>2</sup>) was water-blasted under high pressure to open up the capillary system of the concrete and an additional two coats of crystalline waterproofing were spray-applied at a rate of 0.8kg/m<sup>2</sup> for each coat.

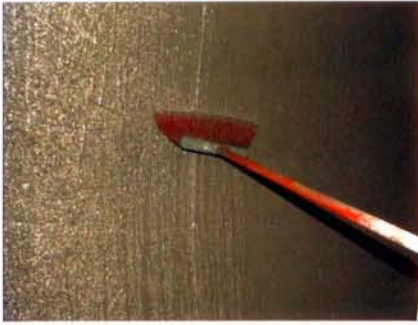
Figure 4 above: Brush distribution of excess material between the two coats.

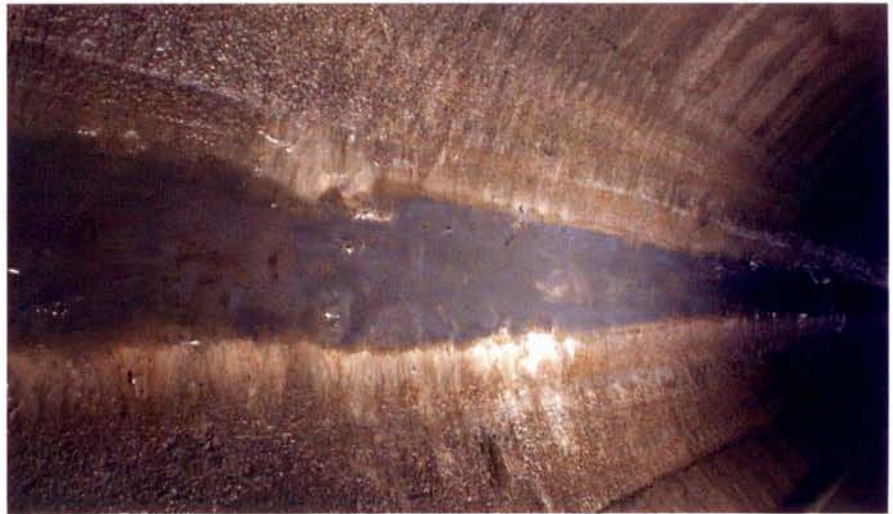
Figure 5 right: Repaired horizontal cracks.

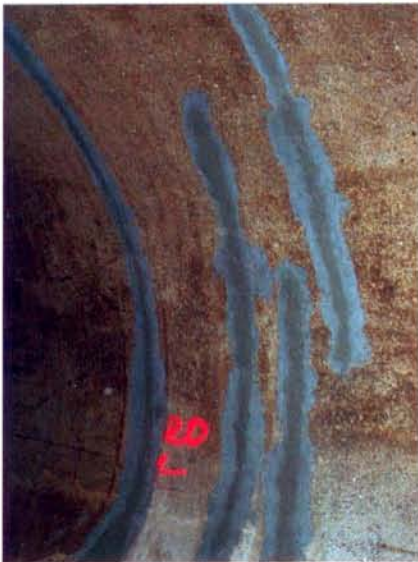
Figure 6: Repaired tunnel construction joints.

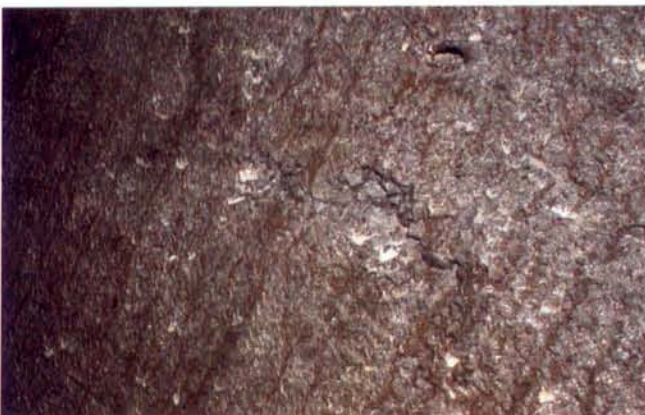
Figure 7: Crystalline waterproofed surface after one week of curing.

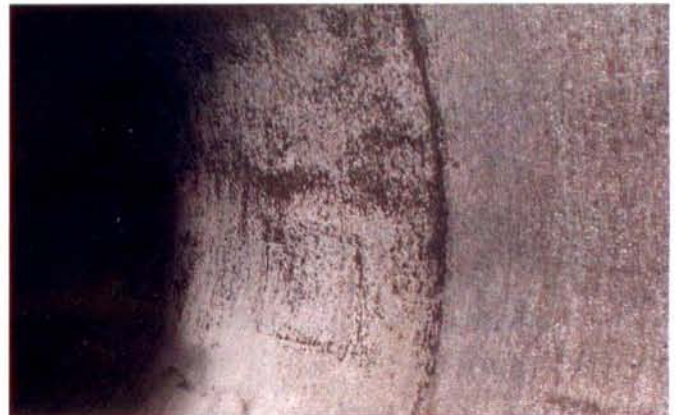
Figure 8: Treated tunnel wall after one week of curing.
